# RIPFLOW MODEL APPLICATION TO RIVER RESTORATION

## Kleblach Case Study

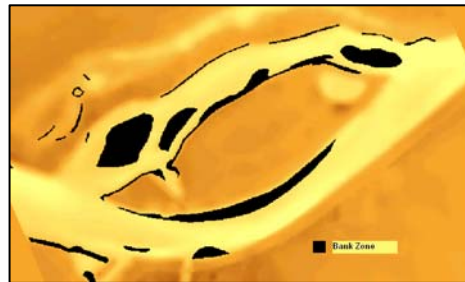
D.E.M. 2003

- Span year 2003 – 2010
- Fix groundwater ( $125 \text{ m}^3/\text{s}$ )
- Max Shear based on measured data
- Morphology change (DEM 2003, 2008)

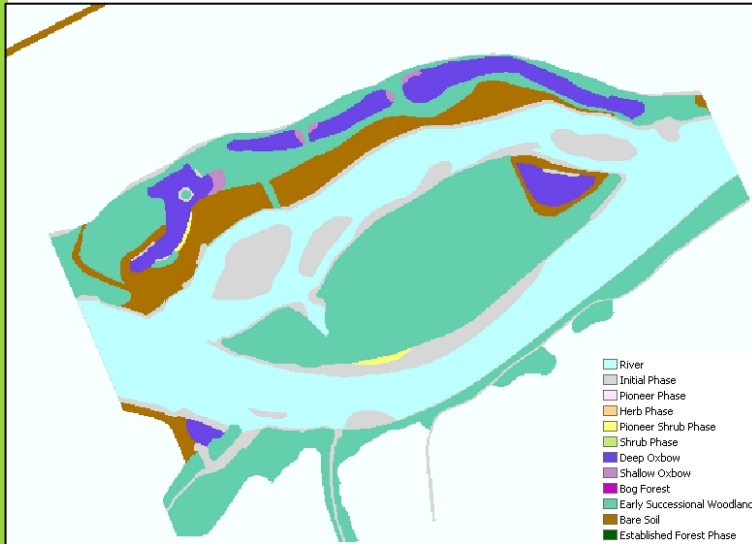
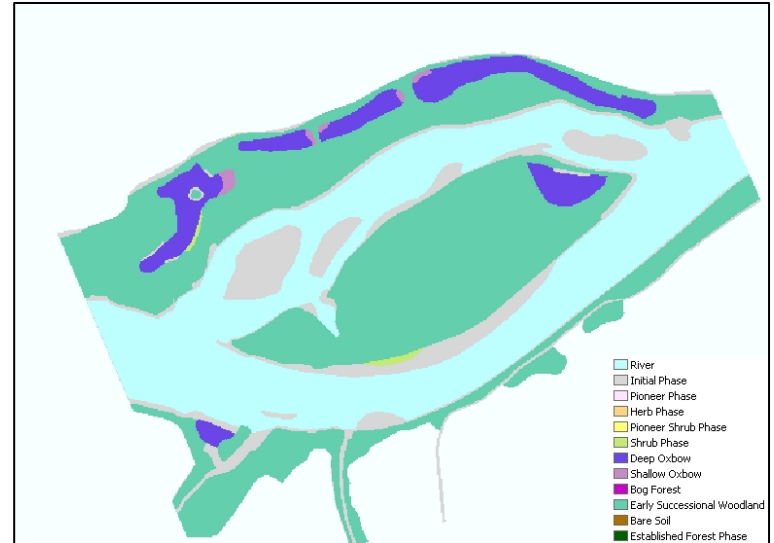
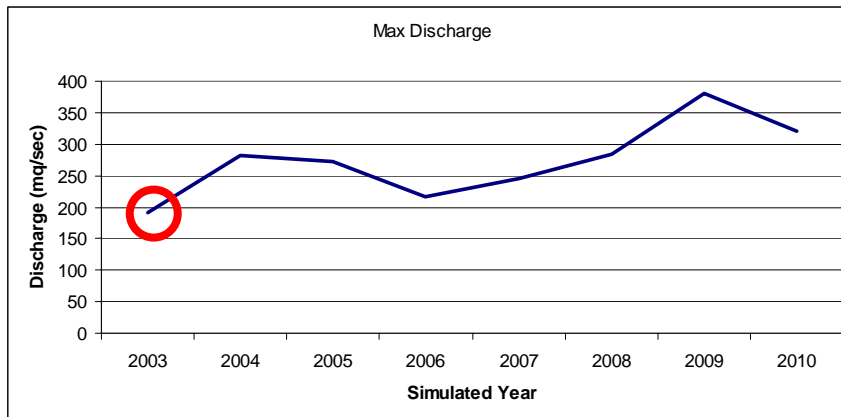
Year 2003

Mapped

Simulated

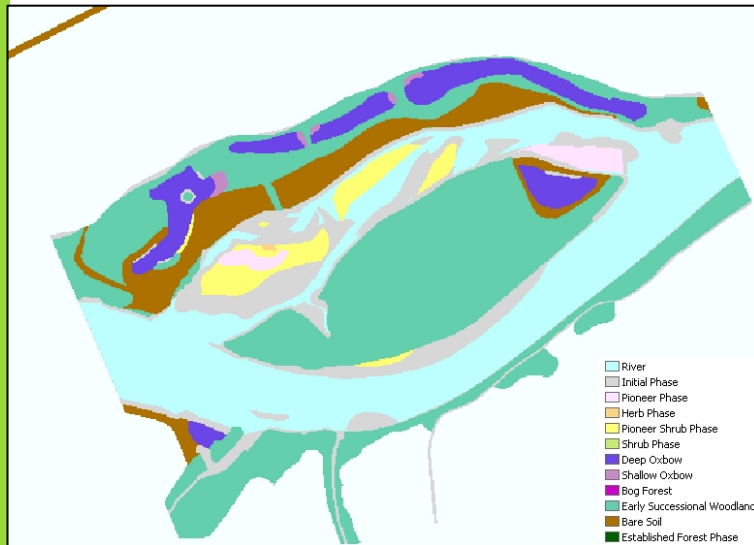
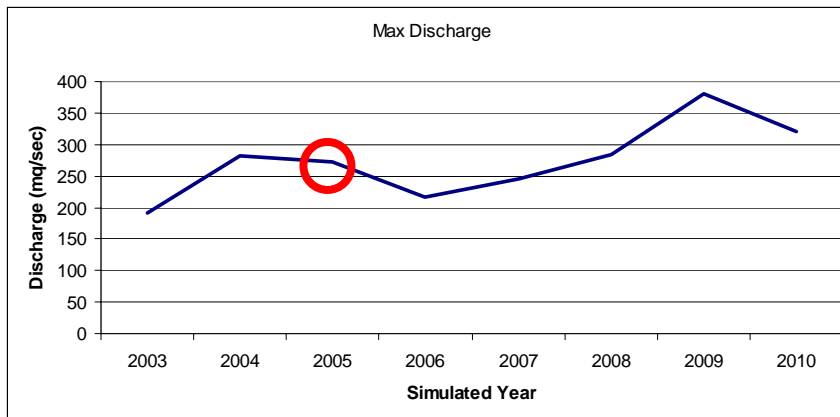
Year 2005

Mapped

Simulated

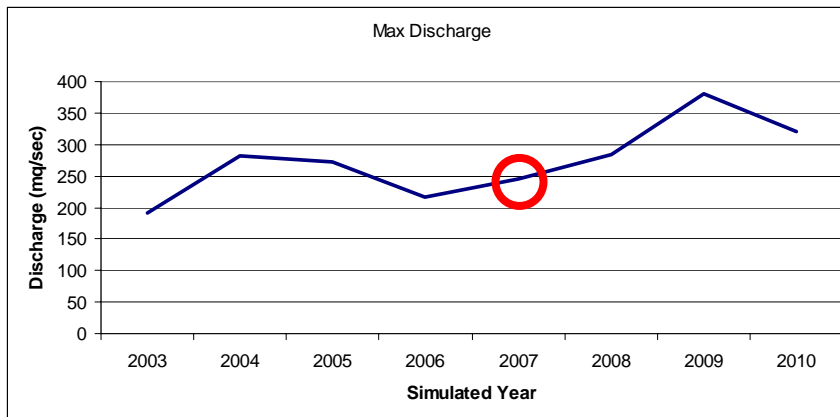
Year 2007

Mapped

Simulated

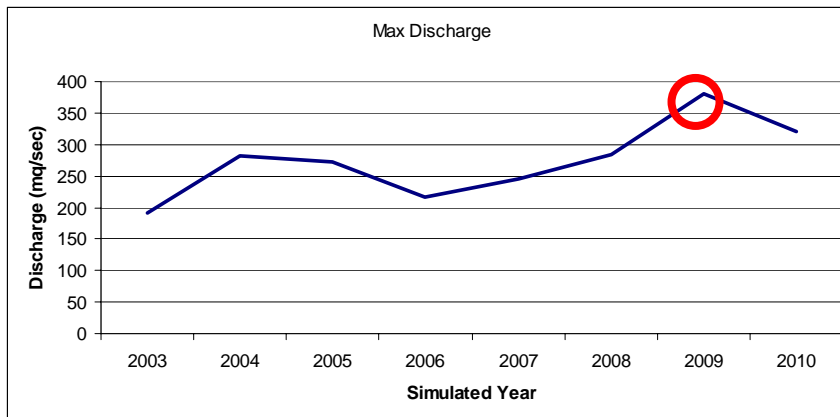
Year 2009

Mapped

Simulated

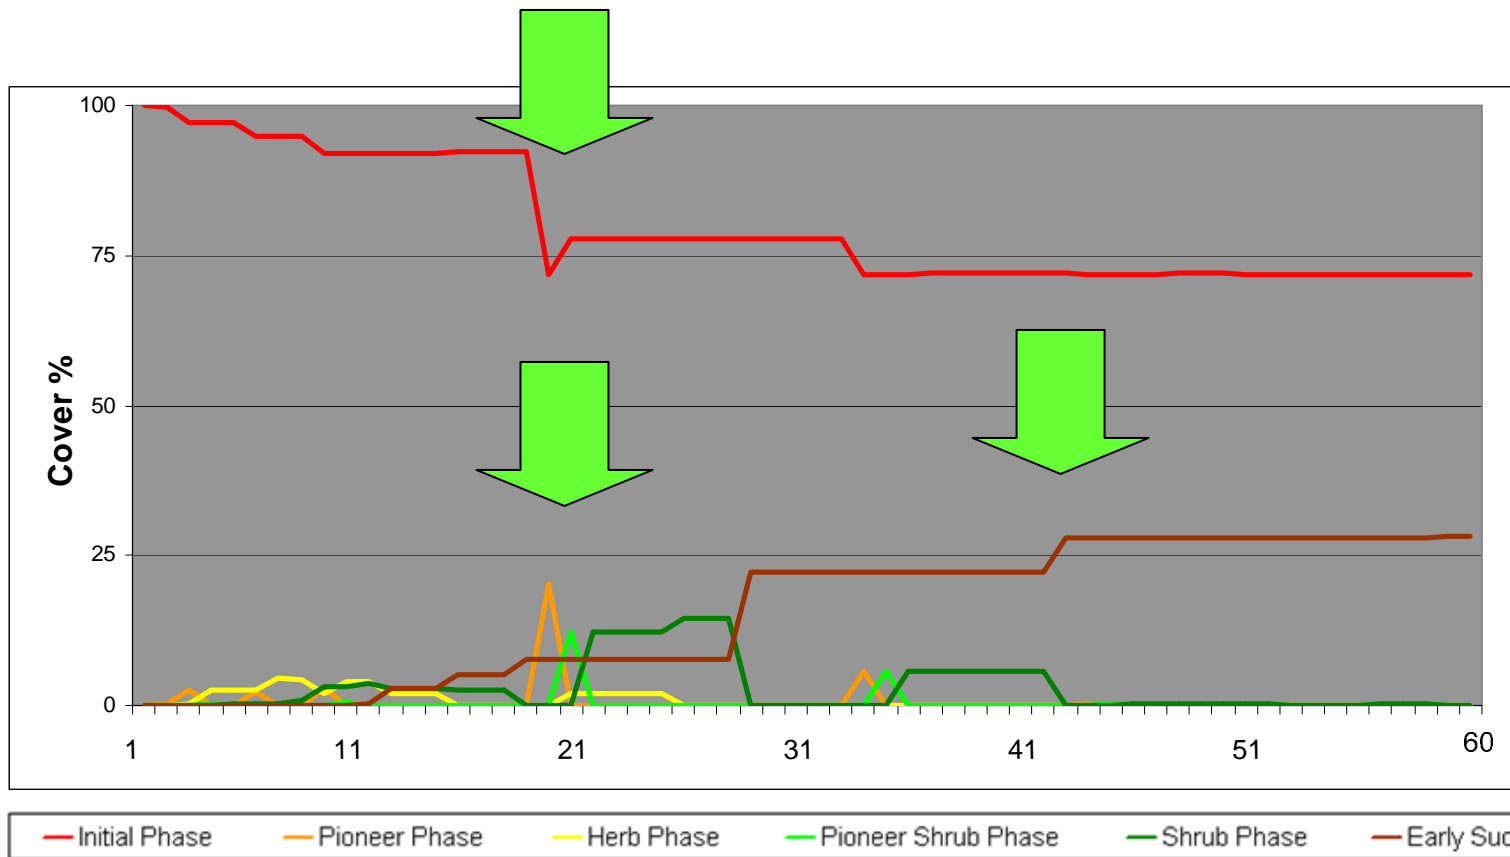
# SCENARIO 1-SMALL IN STREAM ISLAND

- Scenario 1-Small in stream island (2003 DEM)
- Scenario 2-Large in stream island (2008 DEM)
- Simulated years: 60
- Initial phase in the bank zone
- Analysis focus on Bank Zone

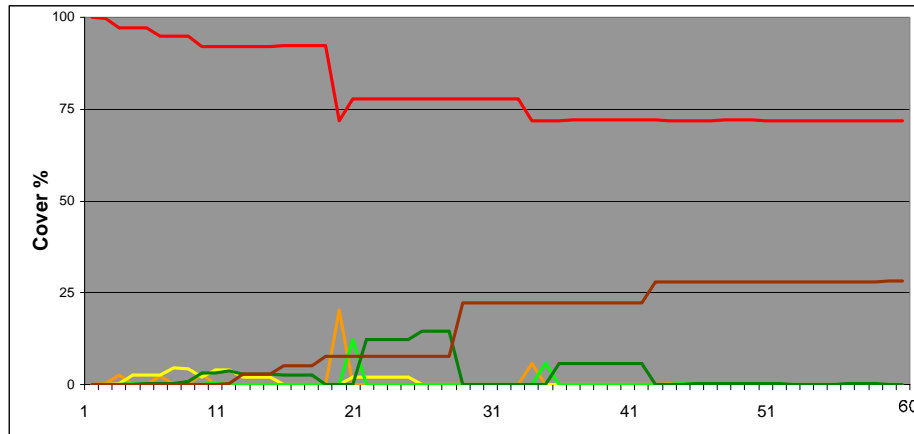
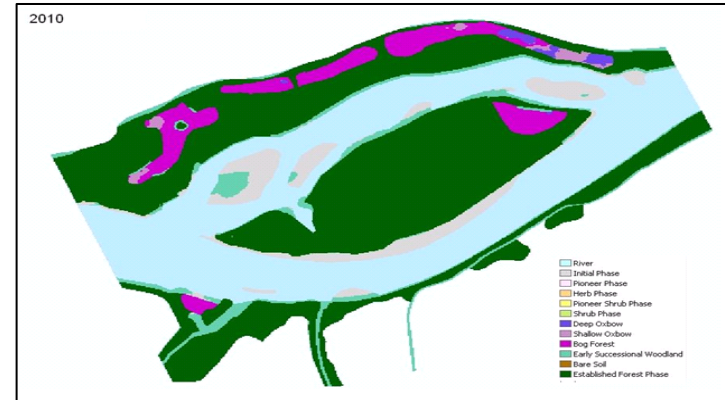
## SCENARIO 1-SMALL IN STREAM ISLAND

— Initial Phase — Pioneer Phase — Herb Phase — Pioneer Shrub Phase — Shrub Phase — Early Succ. Wood.

Too narrow

Regression prevails

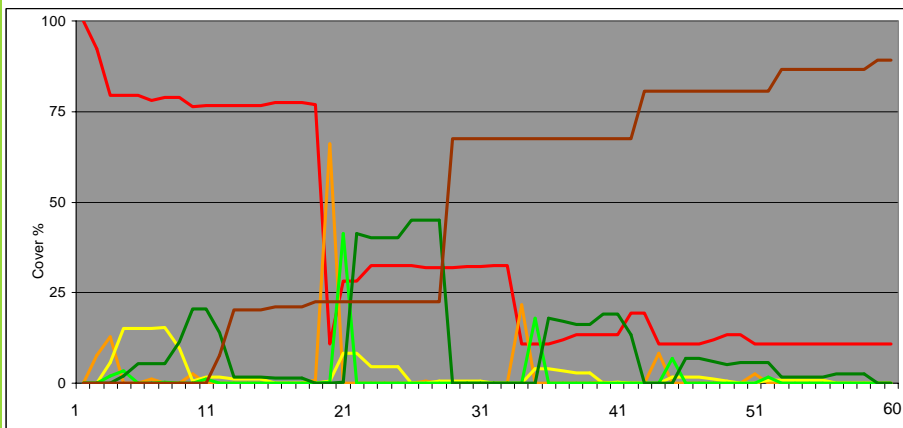
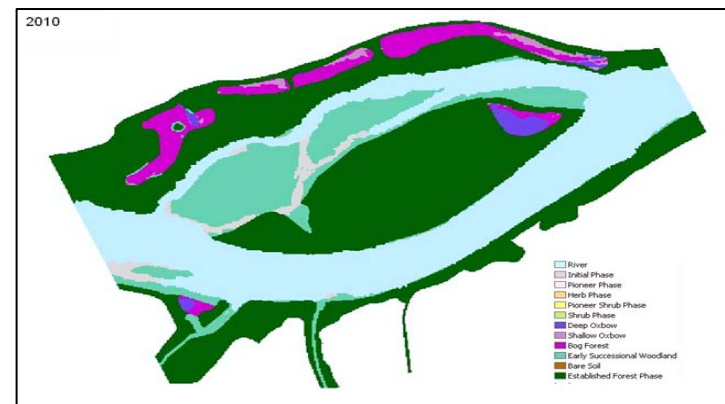
## SCENARIO 2-LARGE IN STREAM ISLAND

— Initial Phase — Pioneer Phase — Herb Phase — Pioneer Shrub Phase — Shrub Phase — Early Succ. Wood.

Too wide

Succession prevails

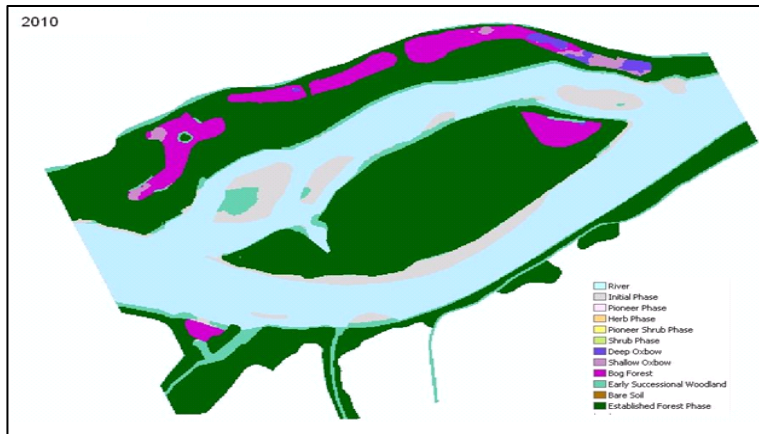
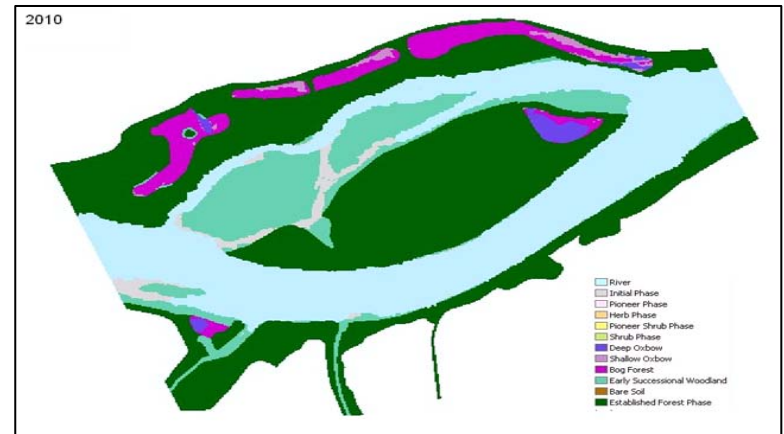
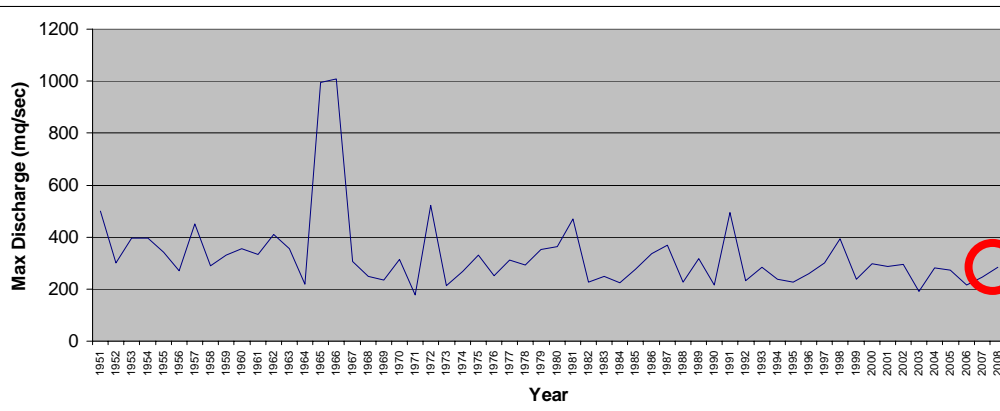
Year 2010 (simulated)

## SCENARIO 1-SMALL IN STREAM ISLAND

## SCENARIO 2-LARGE IN STREAM ISLAND

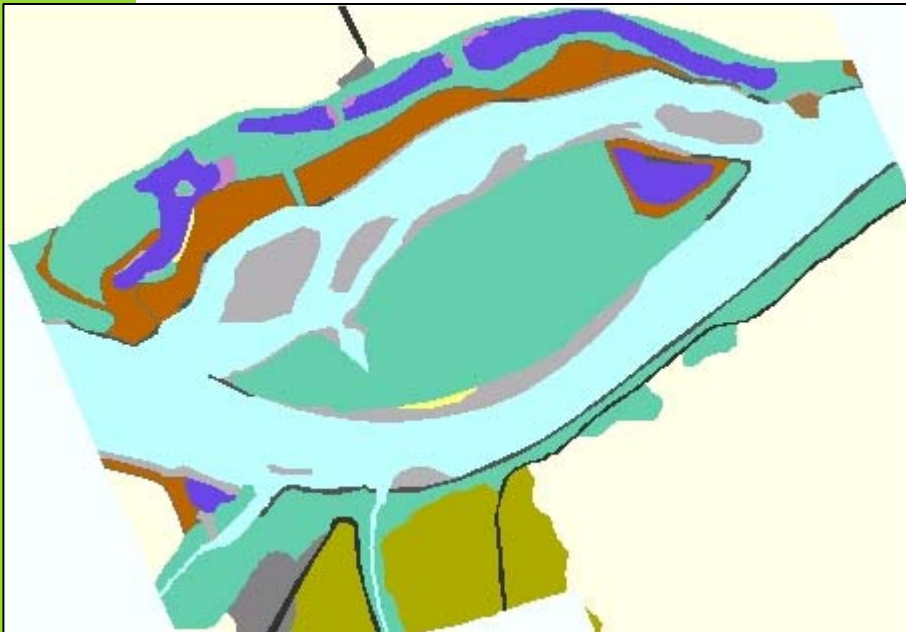
Mapped vegetation 2003

- Model results confirm observed trend
- Uncertainties: sediment transport & bank erosion effects
